TECHNICAL REPORT 3086

INVESTIGATION
OF THE
CAUSE OF AN EXCESSIVE DUD RATE
OF
CARTRIDGE, 40 MM, HE: M406, LOT MA-10-3

JULY 1963

PICATINNY ARSENAL
DOVER, NEW JERSEY

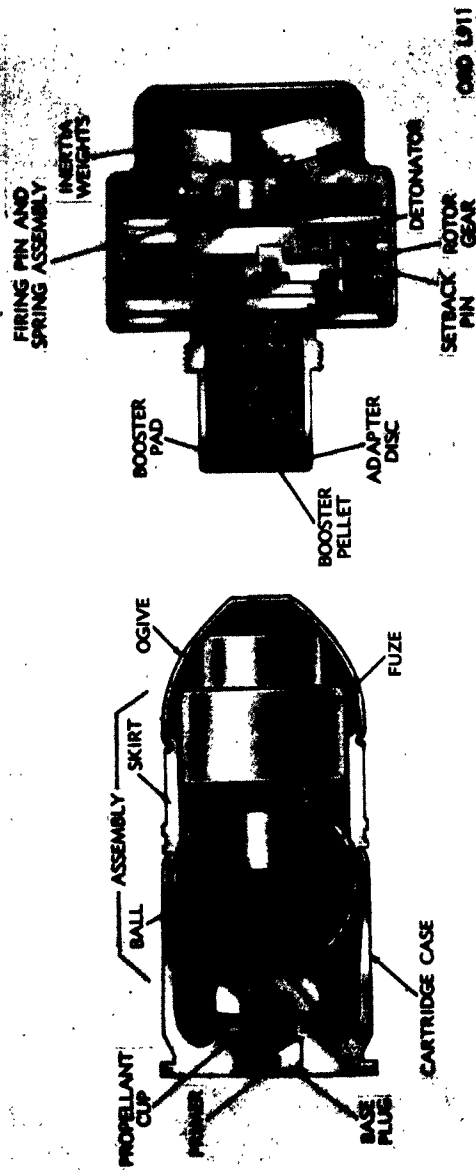
FIGURE 1. CROSS SECTION, CARTRIDGE 40MM HE, M406
CROSS SECTION FUZE PD M551

The purpose of this investigation was to determine the cause of a reported excessive dud rate of Cartridge, 40MM, HE: M406, Lot No. MA-10-63, with M551 Fuze, Lot No. MHR-20-3 (Figure 1). The malfunction occurred 13 August 1962. During a training exercise of L Company, 3rd Battalion, 4th Marine Regiment, six rounds of 75 fired failed to function. Malfunction Investigation File (MIF) Number A-127-62 was assigned and was forwarded to Picatinny Arsenal by the U.S. Army Ammunition Procurement and Supply Agency.

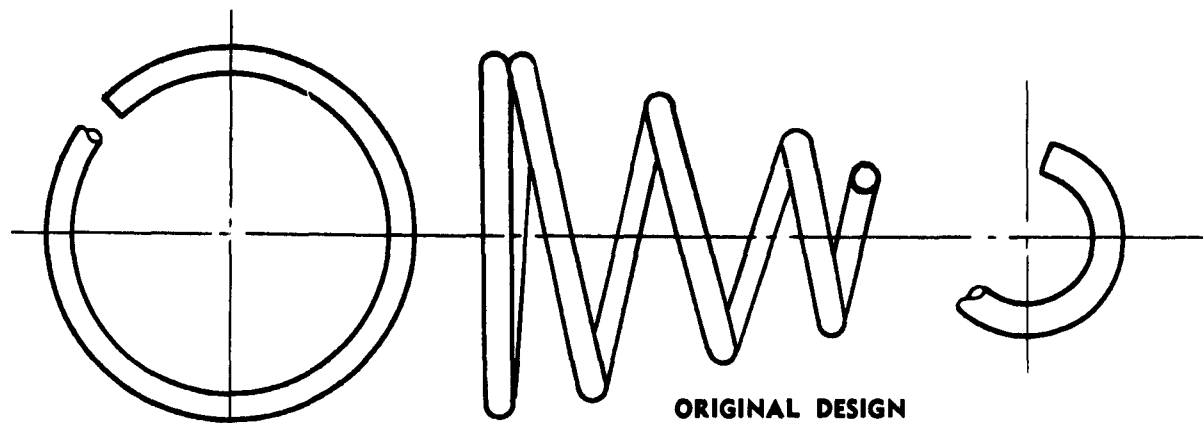
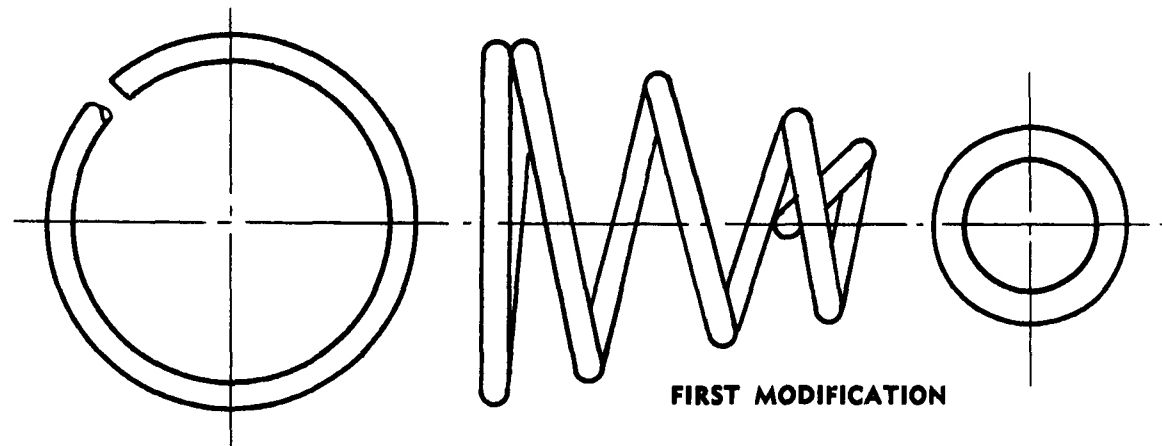
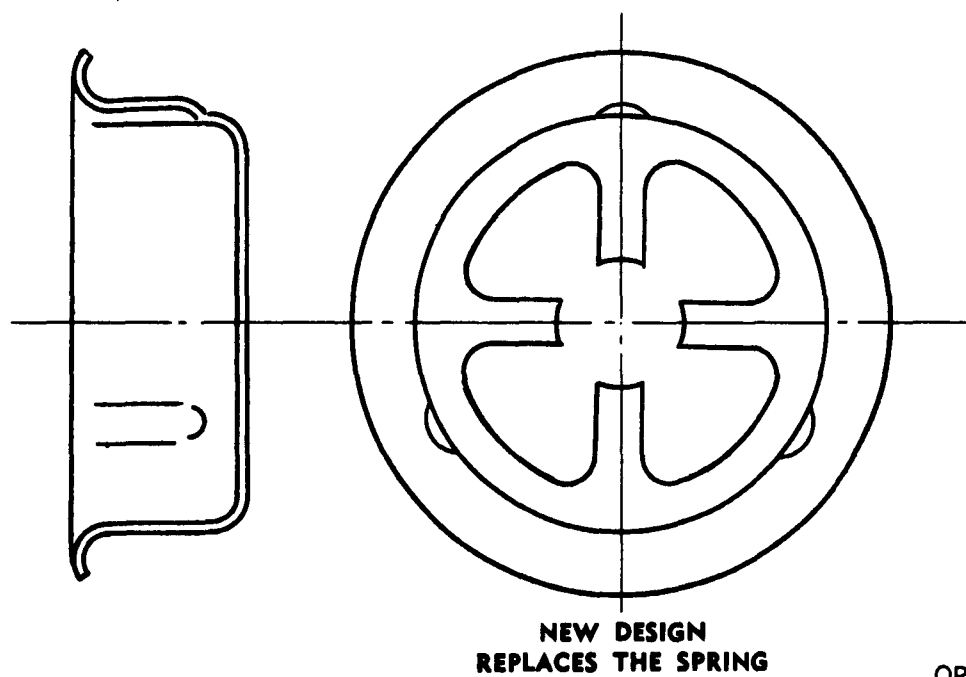
FIGURE 3. SET BACK PIN SPRING AND RETAINER

Set Back Pin re-entry was due to failure of the Set Back Spring to lock the pin when it was fully retracted and prevent it from re-entering the hole in the upper spacer plate -- preventing movement of the rotor to the ARMED position.

1. The Set Back Pin was redesigned and the Set Back Pin Spring was changed to a Set Back Retainer (Figures 3-5).
2. Additional mass was added to the hammerweights.
3. The upper and lower Plate Dowels were removed and incorporated on the Verge Shaft.

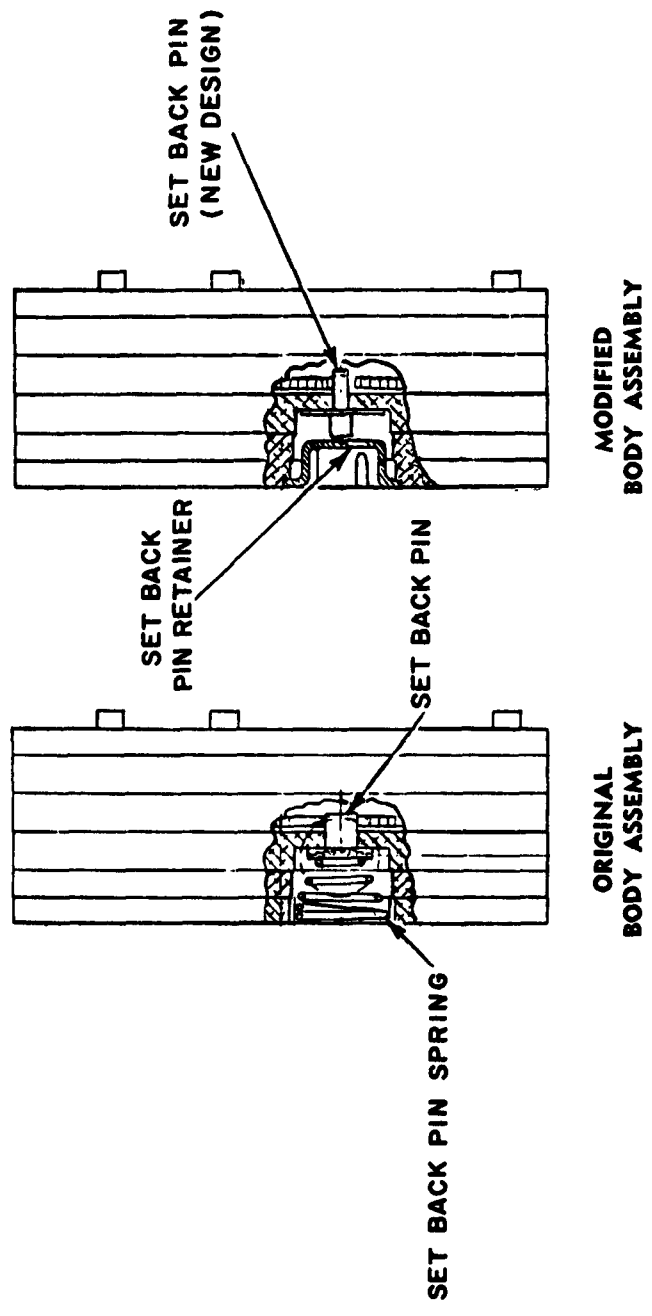
FIGURE 5. BODY ASSEMBLY
-14-

Bent or damaged verge and pinion dowels inhibit the movement of the verge and pinion. This delays the rotor resulting in a dud due to an out-of-line detonator when the projectile impacts on the target.
